BANK LINE SHIFT OF RIVER BRAHMAPUTRA IN MORIGAON DISTRICT, ASSAM (1996-2016)

Abstract:

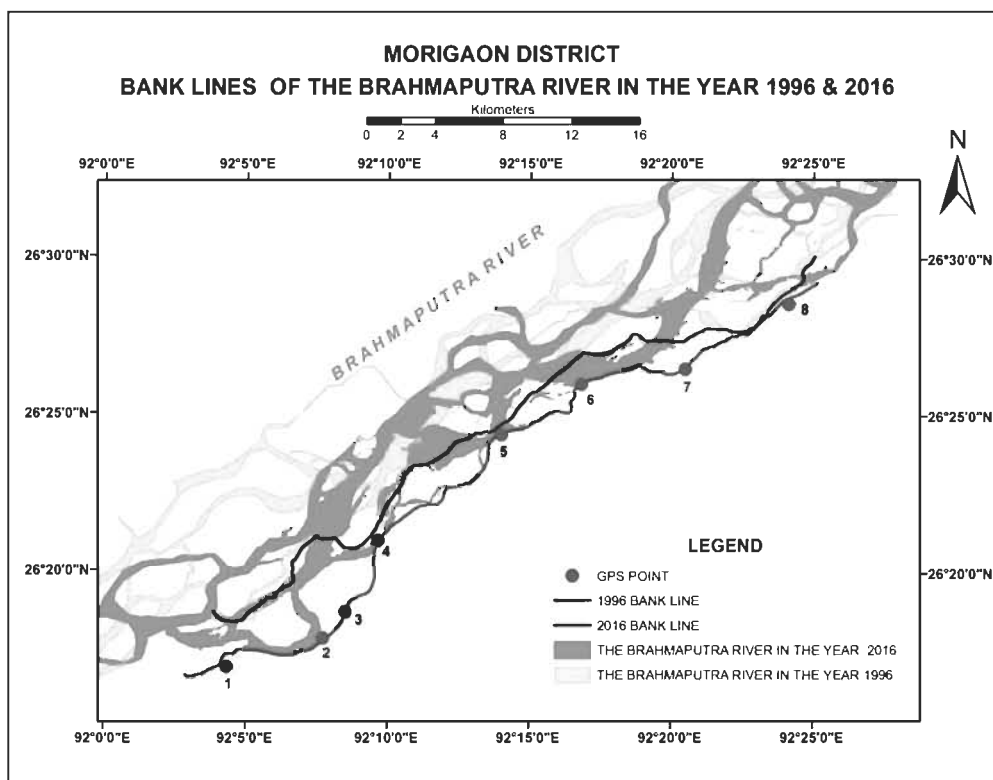
Figure 3: Delineation of river bank line of Brahmaputra (1996-2016)

The Brahmaputra River in Morigaon district from Mayong Revenue circle in the west to Laharighat in the east has been divided into 43 strips at an equal spacing of approximately 1 km, reference cross sections have been drawn at the boundary of each strip. Base line has been taken as permanent reference line, on the basis of 2016 channel flow direction so that they maintain their identity when the morphology is changed. The river bank-line has been identified and delineated from the mosaics satellite images of 1996 and 2016 (Figure 3).

While the shallow water channels have been considered the part of river, old and new soil/sand deposits at the river banks posed some ambiguity of interpretation as the river. A few of these soil/sand patches are at considerable distance from active water channel, but have dark tone on satellite image, indicating higher moisture. On the other hand, several soil patches very close to the active water channel bear bright signature, an indication of low moisture. It has been observed that the areas with recent soil deposits have higher moisture in comparison to other areas adjacent to river bank, due to the river related activities associated with them. Either the river was flowing through that area in the recent past, or that area was submerged in water, when there was high flow in the river. These areas have been marked as a part of river. The identified river bank lines for the south banks of the river have been digitized using GIS software ArcGIS-10.3. Two river bank lines have been prepared for the years 1996 and 2016. The length of banks both the 1996 & 2016 have been calculated using GIS software. Erosion and deposition area has been estimated through area estimation

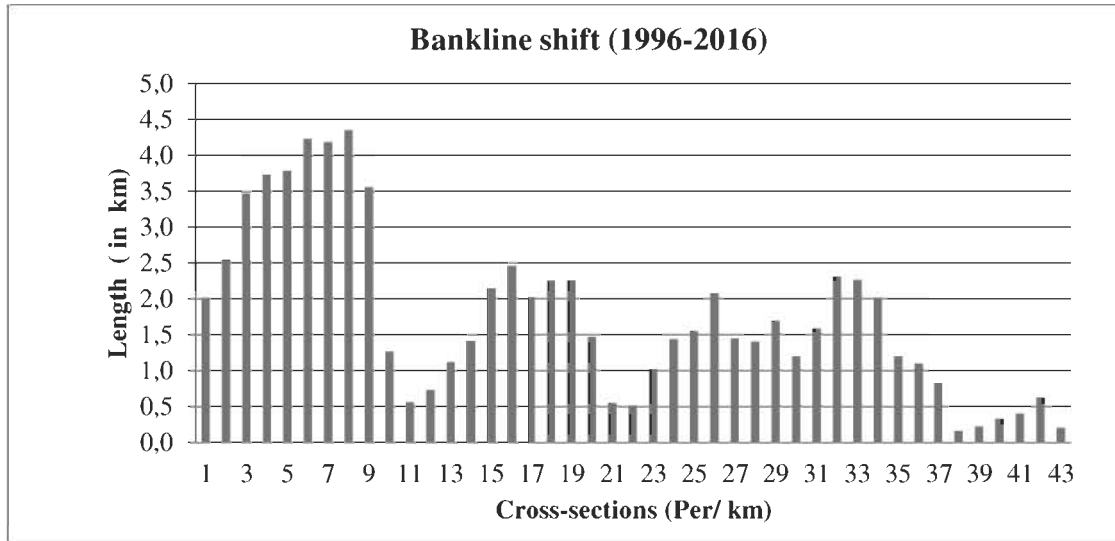
Fig 4: Cross-section of the Bank line shifting (1996-2016).

The most significant shifting of river bank line from 1996 to 2016 is found in the cross section No- 2 (2.55 km), 3 (3.47 km), 4 (3.73 km), 5 (3.78), 6 (4.22 km), 7 (4.18 km), 8 (4.35 km) and 9 (3.56 km) in Mayong Revenue Circle, 15 (2.14 km), 16 (2.45 km), 17 (2.01 km), 18 (2.24 km),19 (2.24 km) and 26 (2.07 km) in Bhuragaon

Revenue Circle and 32 (2.30 km) and 33 (2.25 km) in Laharighat Revenue Circle. The average banks line shifting from all the segments (in 43 cross sections) is calculated to be 1.79 km (1996-2016). The high rate of south ward shift in this section is due to materials composed of non-cohesive river banks silt.

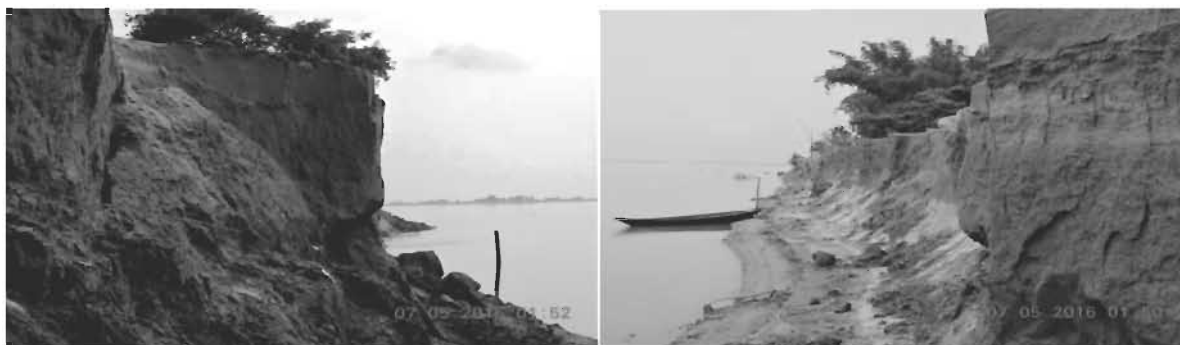
**Image: Bank erosion Boralimari.****PLATES**

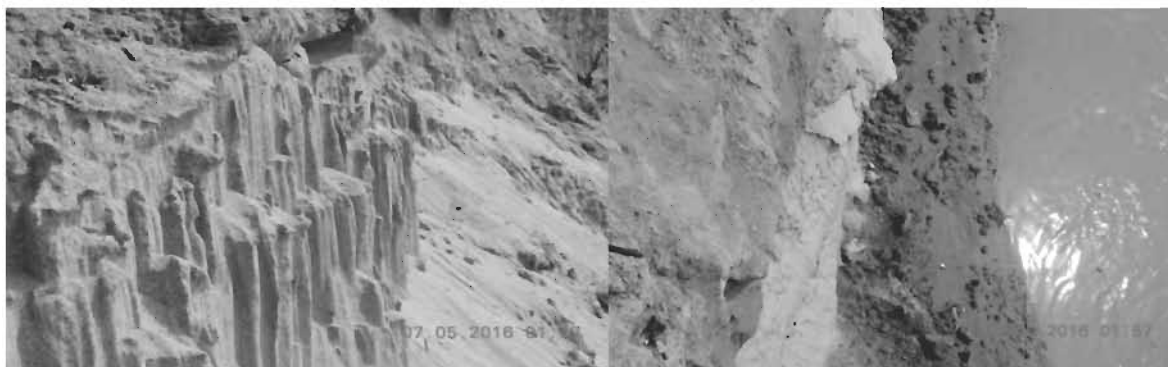
**Image: Properties of Bank line.****PLATES**

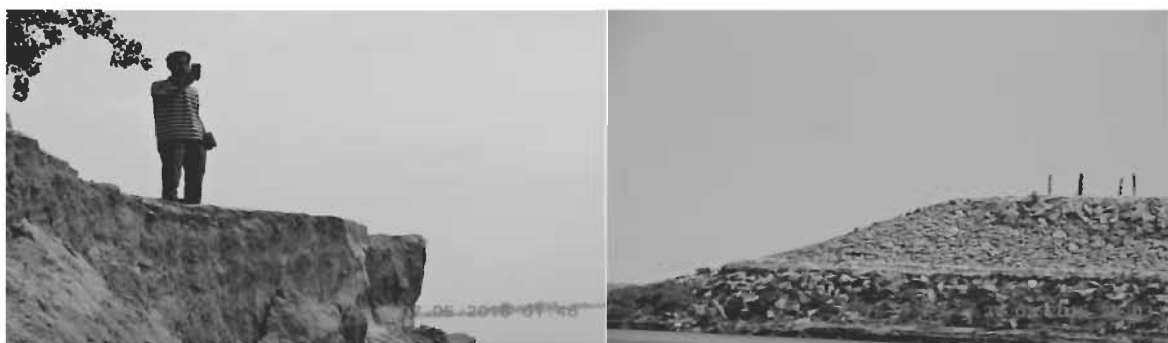
**Field survey with GPS points. Preventive Measure at Bhuragaon Revenue Circle.**
